Appendix 3.9. Asbestos Clearance Certificate 2013

HEC Ref: EP1105 AE
Date: 2 August, 2013

RE: ASBESTOS CLEARANCE;
60-70 BOURNEMOUTH STREET, BUNDEENA NSW 2230

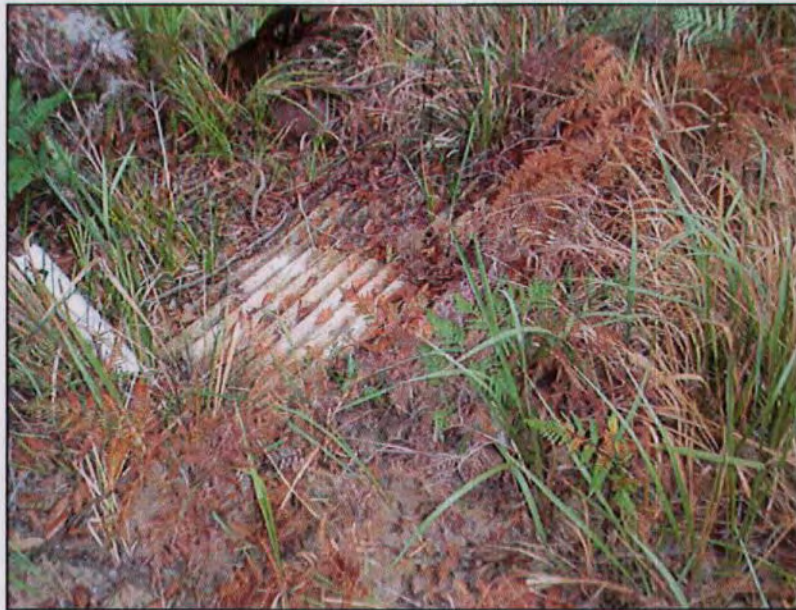
Photo 1. Panels of corrugated FCS in north eastern part of the site.

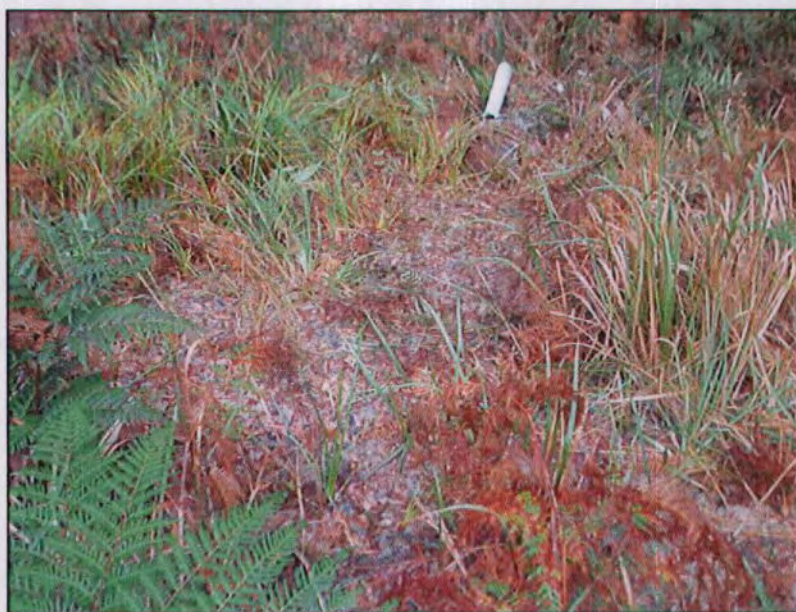
1. No panels of corrugated FCS were present in the designated (previously identified) area.
2. No fragments of FCS were encountered within the north eastern part of the site (i.e. no fragments were observed near the rear (southern) boundaries of 69-71 Beachcomber Avenue).
3. No suspicious odour, or any visual evidence of contamination, was detected on this part of the site.

Photo 2. Remediated area.
